**HELLENIC REPUBLIC
HELLENIC BUREAU FOR MARINE CASUALTIES INVESTIGATION**

**MARINE CASUALTY SAFETY INVESTIGATION REPORT
02/2016**

**Fatal injury of a truck driver onboard
Ro/Ro EUROCARGO TRIESTE**

December 2024

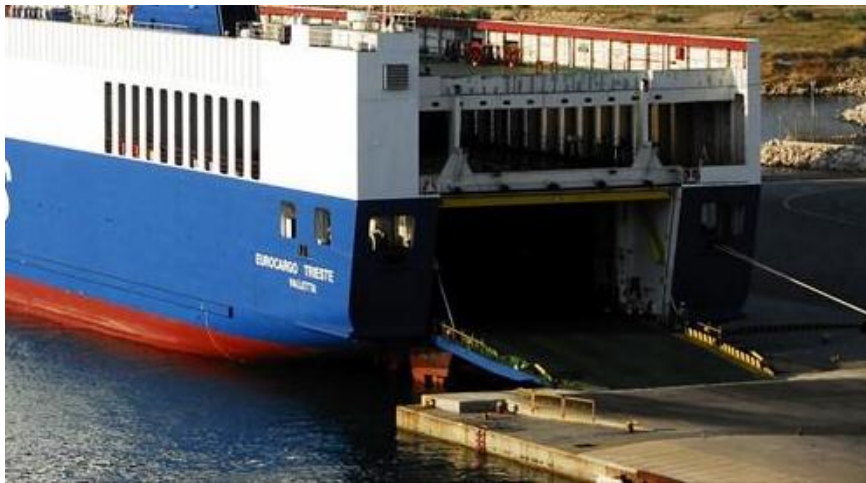
Figure 2: The single loading stern hydraulically driven ramp fitted on no. 2 garage deck (main deck).

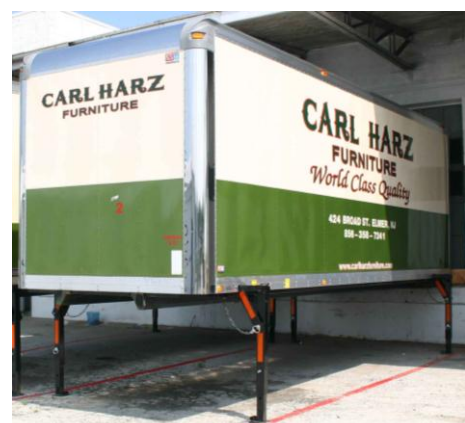
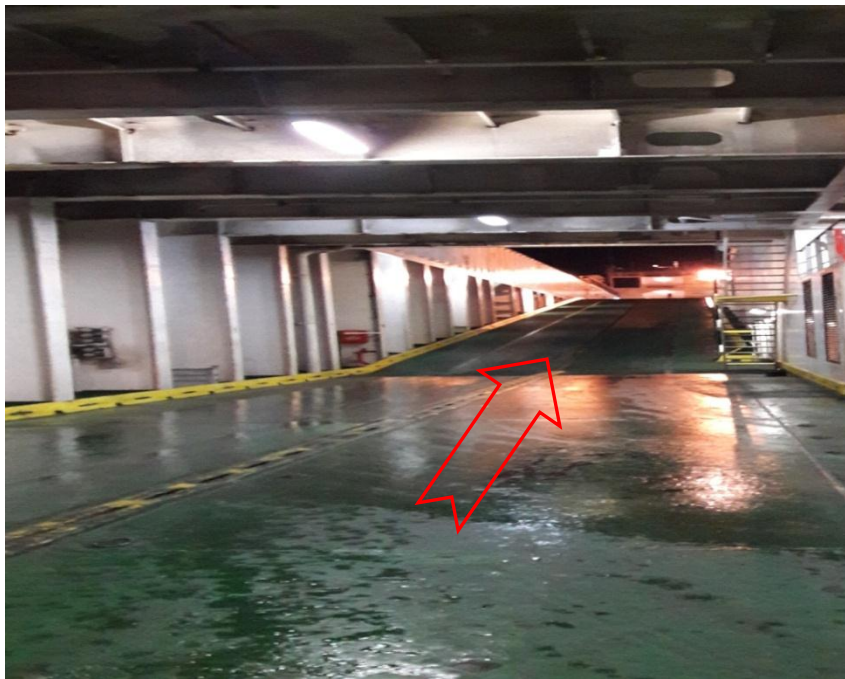
Figure 4: The fixed ramp on garage deck no. 2 leading to garage deck no. 3.

The stowage position was located at the starboard forward end of garage deck number 3 and was indicated by the Ordinary Seaman (O/S) who arrived at the location. At approximately 12:30 the driver maneuvered and aligned the rigid truck within no. 2 parking lane; reversed it towards the vessel's fore and parked it alongside the starboard garage bulkhead of the engine room entrance (figures 4 & 5).

Figure 4: Sketch of the truck manoeuvring to stowage position on garage deck no. 3.

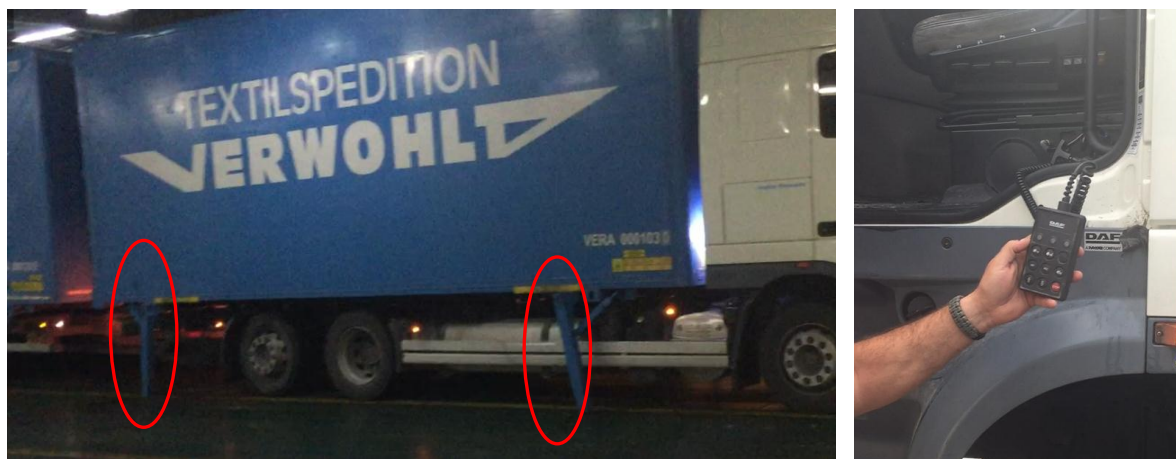
The driver proceeded with setting, at first, the outer side's supporting legs starting from the truck's front (Figure 6) and continued to the inner side's supporting legs starting from the truck's rear end towards the front.

Figure 6. The two supporting legs fitted on the first trailer's outer side and the cabled remote control for the operation of the chassis' air suspension system.

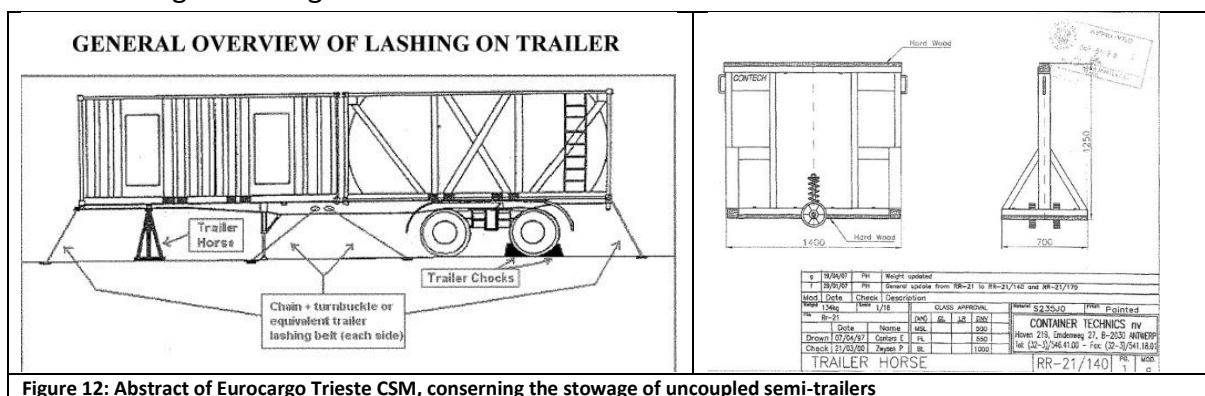
Semi-trailers, commonly carried by ships, by the nature of their design, are not supported on their landing legs during sea transport. As common practice, an uncoupled semi-trailer is supported by a trestle (trailer horse) or similar device placed in the intermediate area of the drawplate so that the connection of the fifth-wheel to the kingpin is not restricted. This method has been examined in terms of the deck’s structural strength as well as the longitudinal, transverse and vertical forces applied during the voyage, especially on adverse weather conditions, and specific instructions have been incorporated to the vessels’ Cargo Securing Manuals.

Figure 12: Abstract of Eurocargo Trieste CSM, concerning the stowage of uncoupled semi-trailers
