**HELLENIC REPUBLIC  
HELLENIC BUREAU FOR MARINE CASUALTIES' INVESTIGATION**

**MARINE CASUALTY SAFETY INVESTIGATION REPORT  
04/2018**

**GROUNDING AND FOUNDERING OF TUG BOAT VIKING**

**January 2021**

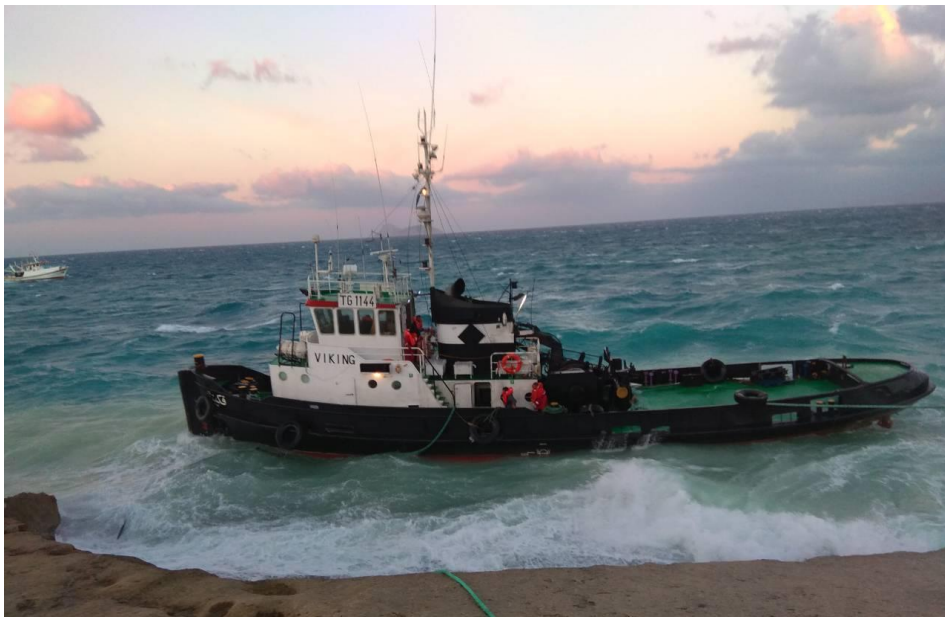
Figure 1: tug boat VIKING

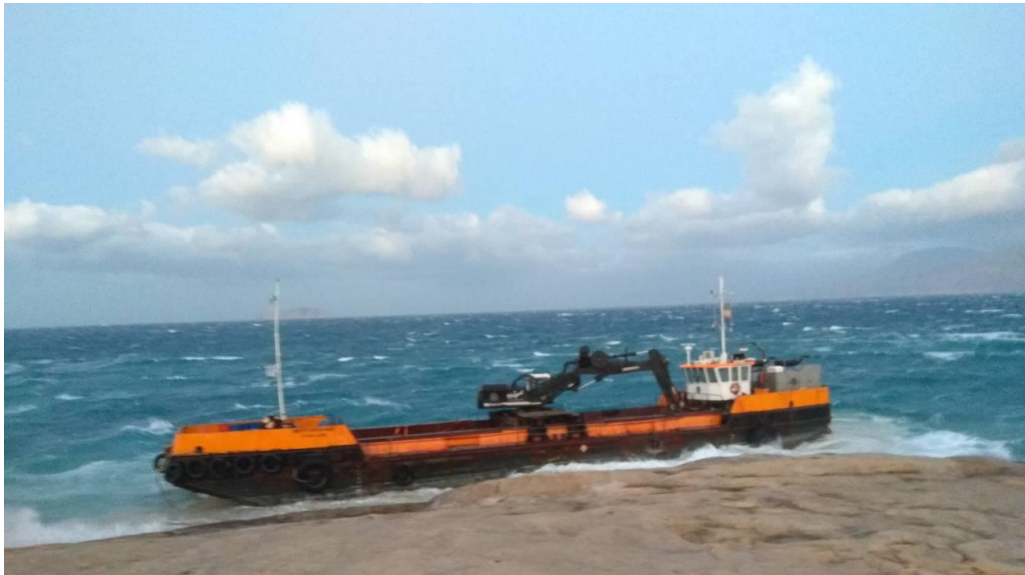
Figure 2: Dredger NEPTUN KHAN

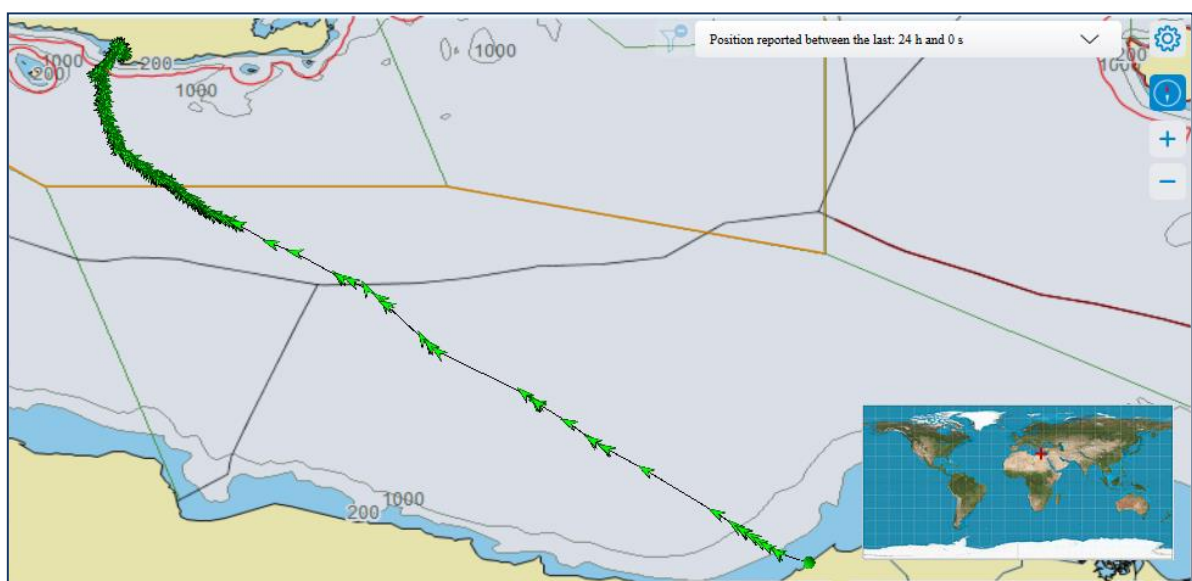
**Figure 3:** The route followed by the convoy of T/B VIKING and towed vessel, from Alexandria (Egypt) to the S of Crete island (Greece) (source: EMSA/IMDatE)

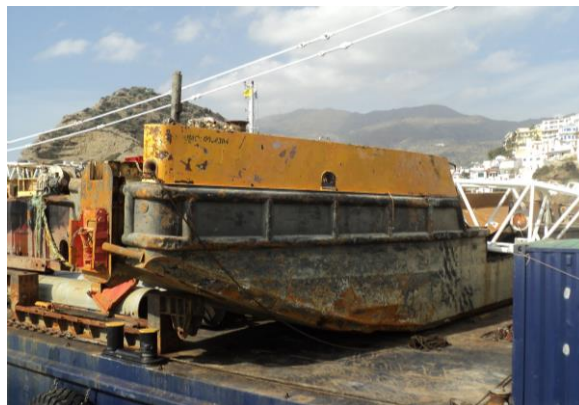
The managing company of NEPTUNE KHAN salvaged the vessel on the 13<sup>th</sup> of February 2019.

**Figure 11:** capture of the NEPTUNE KHAN on the salvage platform
