**HELLENIC REPUBLIC  
HELLENIC BUREAU FOR MARINE CASUALTIES INVESTIGATION**

**MARINE CASUALTY INVESTIGATION REPORT**

**07/2015**

**GROUNDING OF B/C GOODFAITH  
ON ANDROS ISLAND ON 11-02-2015**

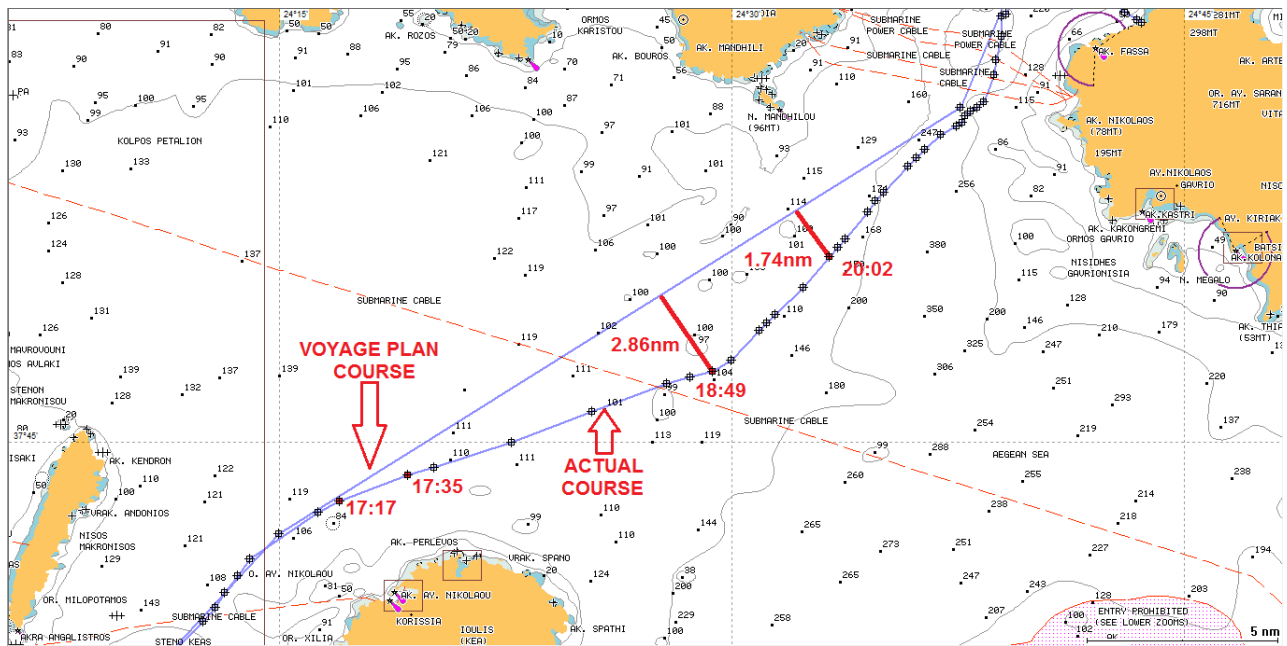
At approximately 17:00 (Figure 4) Goodfaith passed her next way point at position 037° 42'N, 024 15'E, where a change of course to 052° was planned. At 1717 she had cleared Keas Strait and sea speed (SOG) was decreased to approximately 6 knots. While proceeding towards Steno Kafirea the weather conditions had further deteriorated and wind at force was recorded at 10Bfrs. It was reported that the ship’s yaw<sup>2</sup> was reaching almost 20° in the 50-60 knots winds. At approximately 1735 in order to reduce the effects of the big waves the Master ordered the Chief Officer to set the steering to manual and maintain a course 030°, in order to navigate with the sea at the vessel’s port bow. By 1849 Goodfaith’s speed was approximately 5 knots (SOG), however the vessel was drifting Southeasterly with an approximate COG 61°, and she was 2.86 nm south off her charted course. In order to bring Goodfaith back to the charted course, the heading was readjusted to port and by the end of the watch at 2000 the ship’s COG was recorded to approximately 32° while Goodfaith was making a slow progress approaching to Steno Kafirea with an average SOG of 4 knots.

**Figure 4:** Goodfaith off course position at approximately 17:35, 18:49 and 20:02 heading to Steno Kafirea

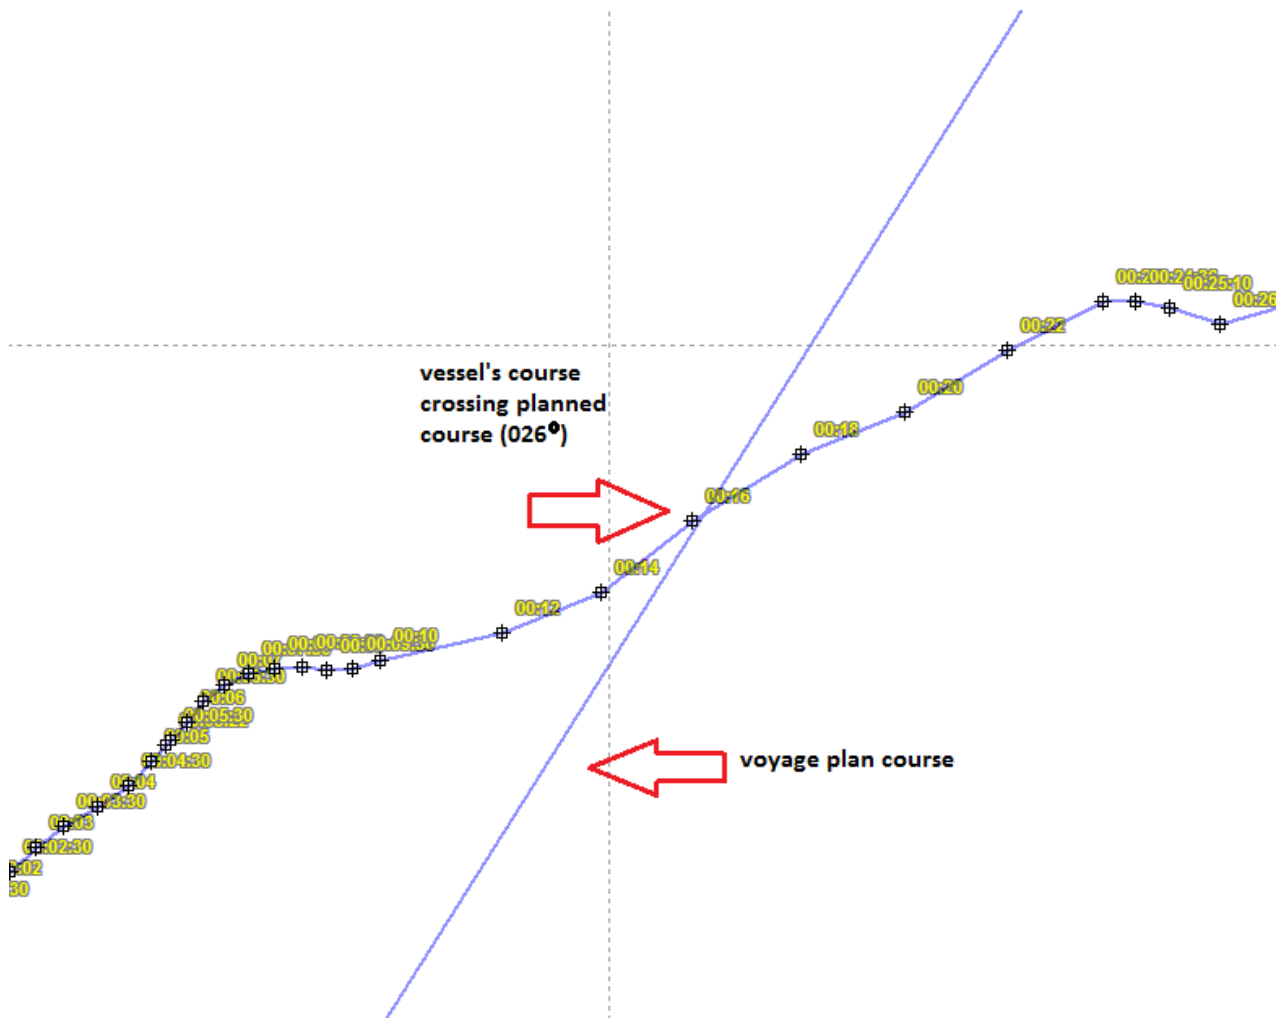
Figure 6: Goodfaith position a few minutes after the change over of the watch (00:16)

A few minutes after the change over of the watch at 0016 the vessel's course (Figure 6) had crossed the plotted course (026°) as projected on the plan under her passage plan but that was not recorded on the chart. By that time Goodfaith was nearly exiting the Steno Kafirea heading towards the fully exposed to North winds area of the Central Aegean Sea. From the information collected through the VDR data and the sound recordings from the bridge, it was evident that the prevailing weather conditions had a severe impact on Goodfaith's navigation, on the grounds that she was making a slow progress on her passage with her speed (SOG) at times being less than 2.0 knots and her COG to almost 62° despite the fact that her heading was 24°, close to the planned course (026°). The last fixing of the vessel's position on the chart was marked at 2400; however it is noted that according to the VDR data the vessel's position was wrongly marked as the actual position at that time was nearly 1.2nm south-west of that point (Figure 7). The wrong position on the chart indicated that the vessel had drifted almost 0.5 nm East from her planned course and she was almost 2 nm away from the North west coast of Andros. Nonetheless the OOW did not alter the vessel's course to north and proceeded with the same course.

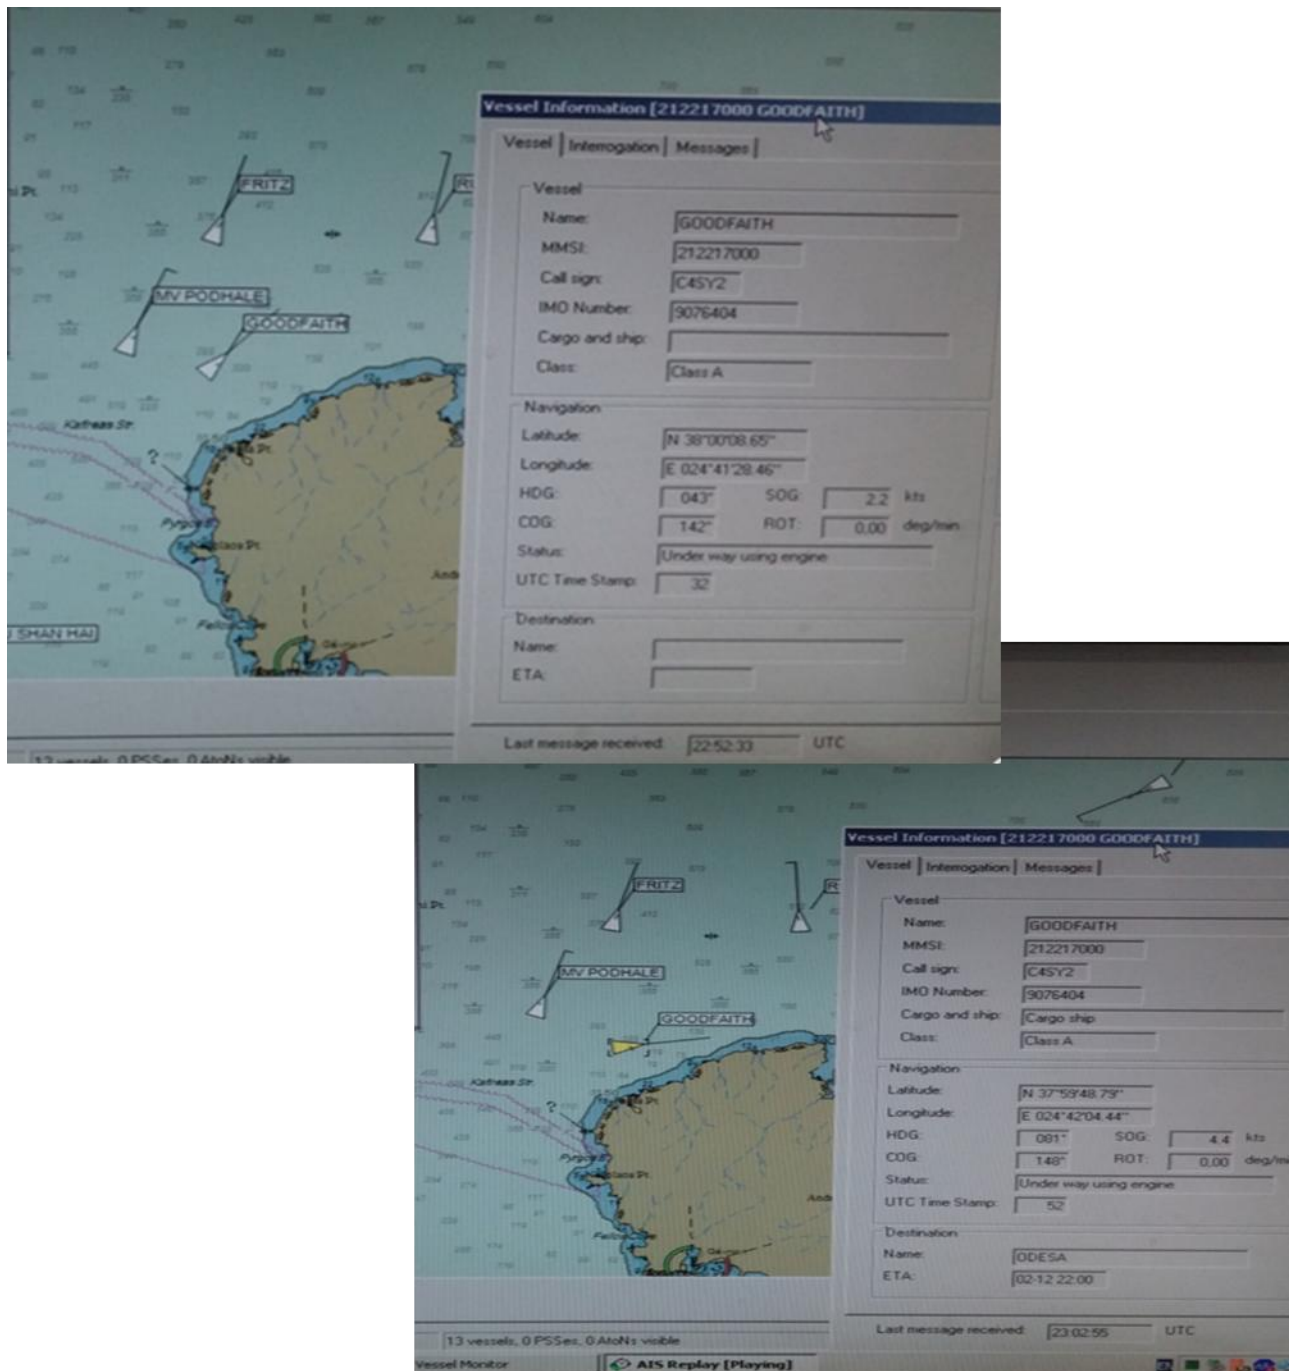
As the vessel was exiting Steno kafirea she started drifting further to East following an almost 80° course as she was affected by the strong north winds of 50-60kn and the high waves coming from the open Central Aegean Sea as Goodfaith's heading was highly increased from 30° to 81° with a respective increase of COG to 148° (Figures 8,9) and the vessel was approaching the Northwest coast of Andros, with a SOG of approximately 4,5 knots.

**Figures 8,9:** Goodfaith's positions at 00:52:33, HDG 043° (COG 142°), SOG 2,2 knots and at 01:02:55, HDG 081° (COG 148°), SOG 4,4 knots. (Source: SafeSeaNet)

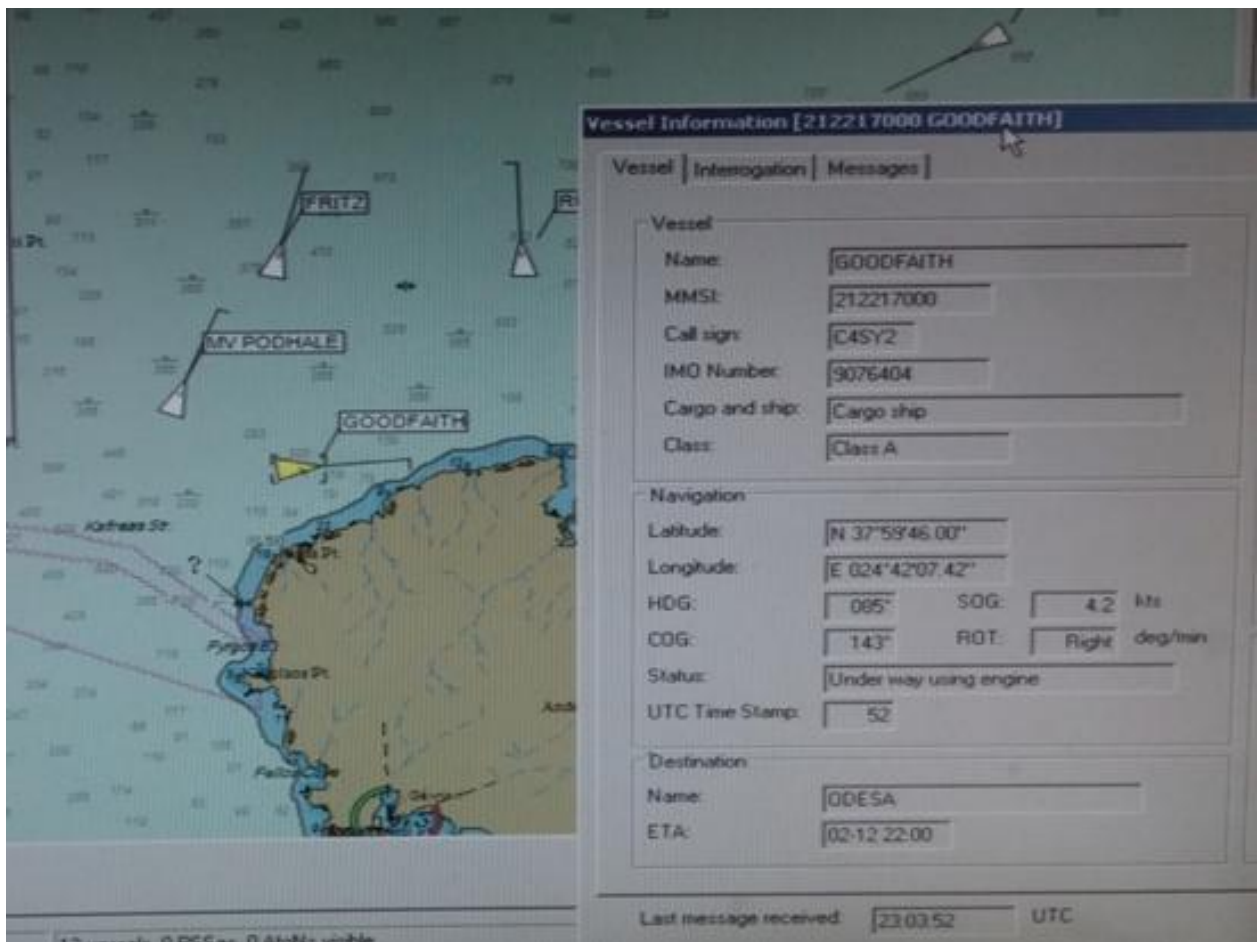
At approximately 0100 the general alarm was sounded by the Master, while Goodfaith was recorded to heavily drift to starboard, with a heading of 85°, a COG of 143°, a speed of 4.2 knots while she was almost 1.7nm off the NW coast of Andros Island. Goodfaith was practically not under command making no headway, despite the fact that her engine was running at 95 rpm. At 01:07:30", the Master realizing the imminent danger of grounding ordered the crew to muster at the bridge by the public address system. All crew members except the crew assigned at the steering gear room, were mustered on the bridge with their lifejackets and immersion suits on. No further actions were taken by the Master and Goodfaith was actually not under command, laying beam on to the wind and the high waves of more than 7-8 m height, as reported by her crew, that were causing heavy rolling.

Figure 10: Goodfaith's position at approximately 01:03 (source AIS information system)

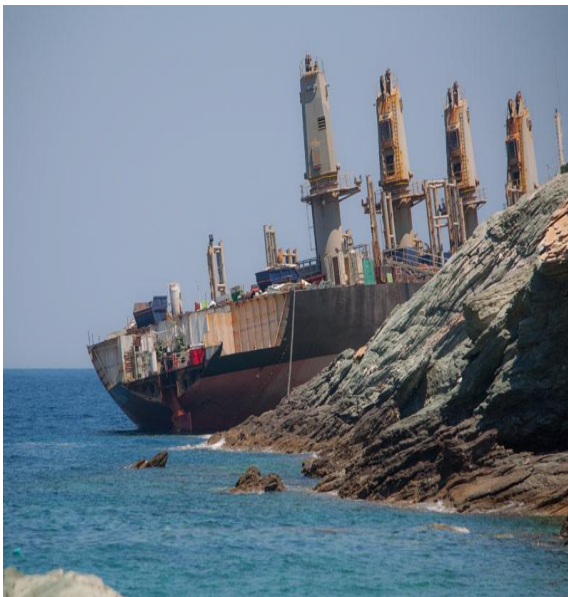
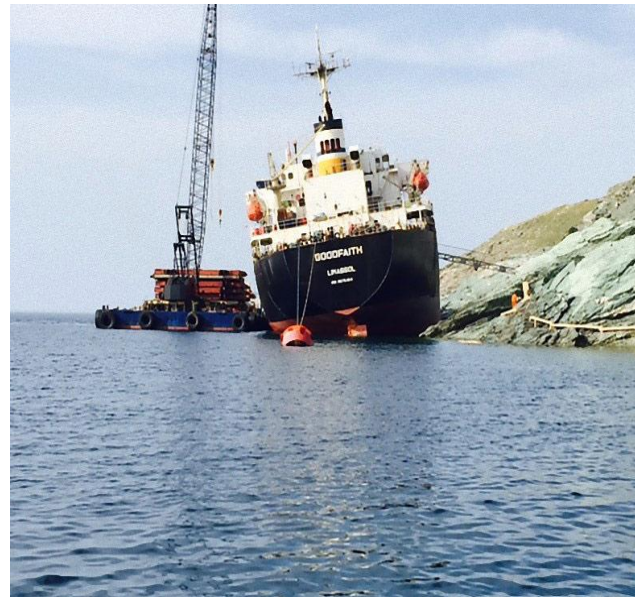
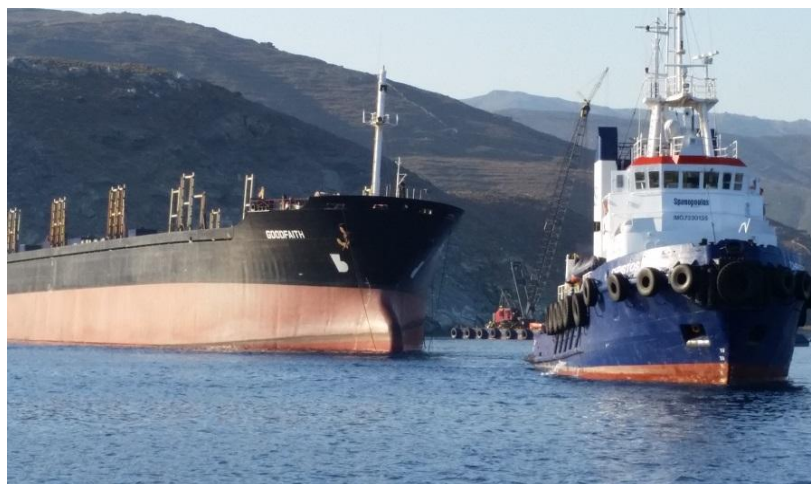
Bearing in mind the actual extend of the damages as found above and calculating the estimated costs for the proper repairs of the M/V Goodfaith to be reinstated in her full operating condition, it was apparent that the repair costs exceeded the insured value of the vessel therefore she was considered a constructive total loss.

**Figures 19 a, b, c:** Photos from the wreck removal operation and the vessel being removed from the casualty area (source contracted Salvage Company).

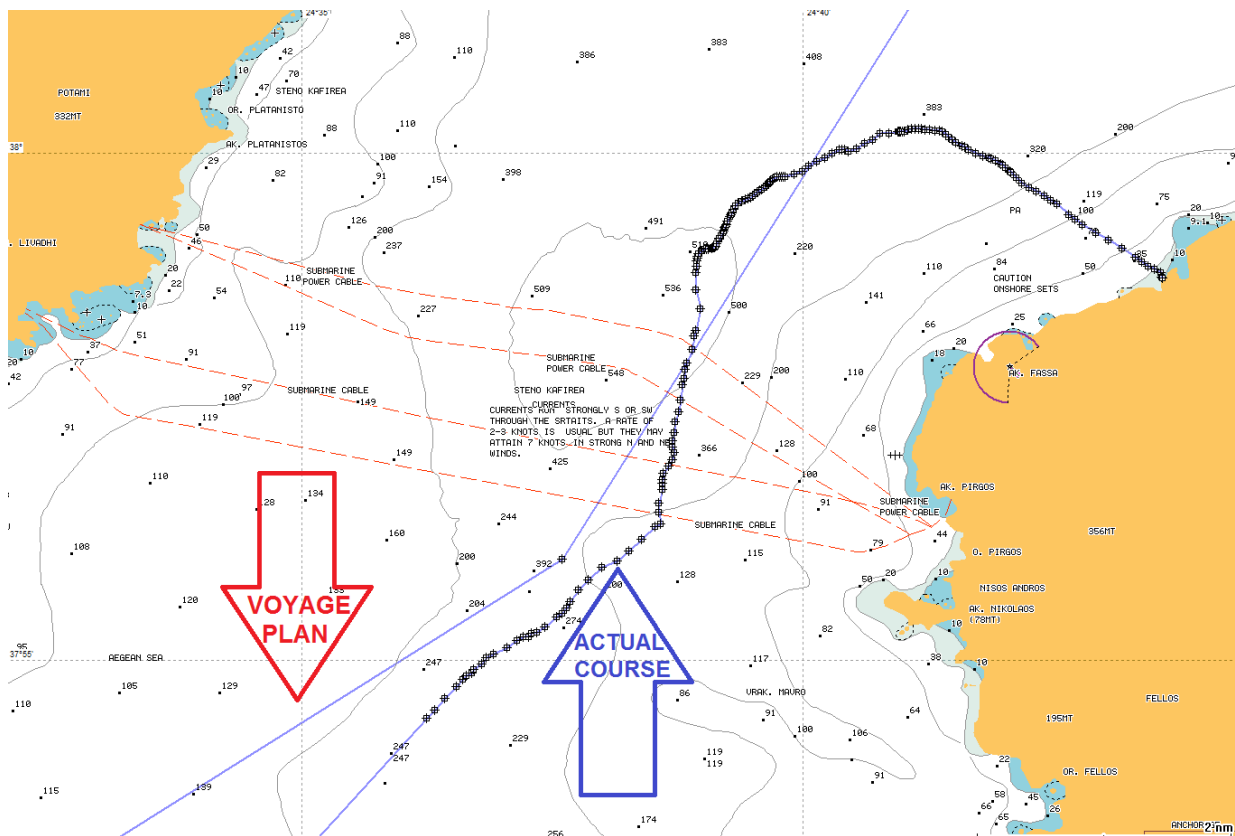
Based on the aforementioned data, the course of the casualty vessel was projected on an electronic chart, in order to reconstruct the passage leading to her grounding. An overview of the plotted positions is presented in figures 20, 21 in contrast to Goodfaith's planned course, as recorded on the navigational chart.

Figure 20: Goodfaith voyage plan and positioning data as plotted on electronic chart.

The examination of the used paper chart showed that the vessel's positions, prior to the casualty were recorded on a frequent basis since 2100, when Goodfaith was entering the Kafirea strait, until almost 2400 during the changeover of the watch. In fact at 2400 the last vessel's position on the chart was recorded, almost 1½ hours before her grounding. Similarly the last record of the vessel's position on the bridge log book was recorded at 2200 almost 3½ hours before her grounding. However as mentioned earlier, in the narrative part of the report (see Figure 7), the position obtained at 2400 was wrongly marked on the chart as Goodfaith at that time was actually located nearly 1,2nm Southwest of that point.

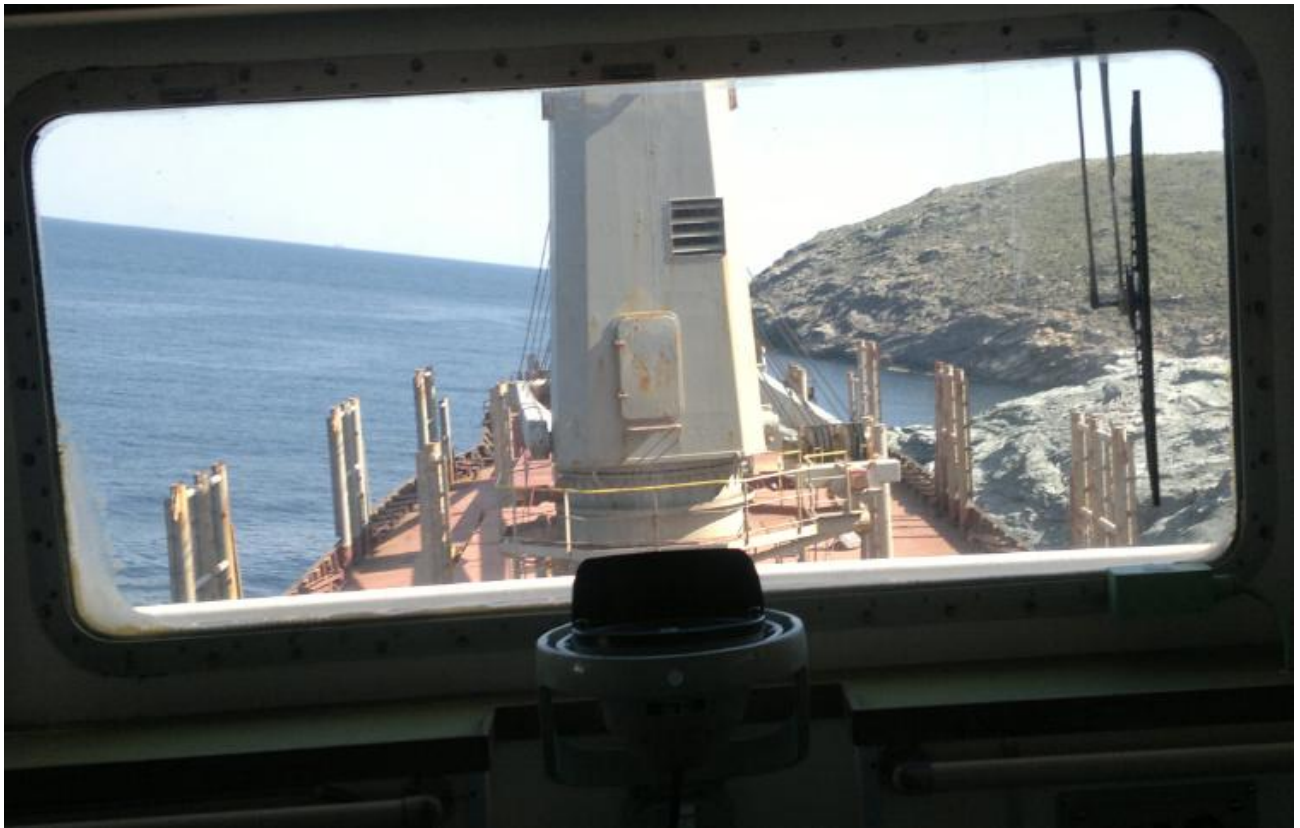
Goodfaith's wheelhouse structural arrangement offered a good visibility from the conning position to the navigated sea area. The OOW could maintain a very good visual contact and monitoring of surrounding vessels and land. However, her cargo cranes located in line amid ships, created a limited blind horizontal sector, as usually exists on such type ships which could be administered by the relocation of the OOW at the bridge wings.

*Figure 25: Goddfaith conning vision*

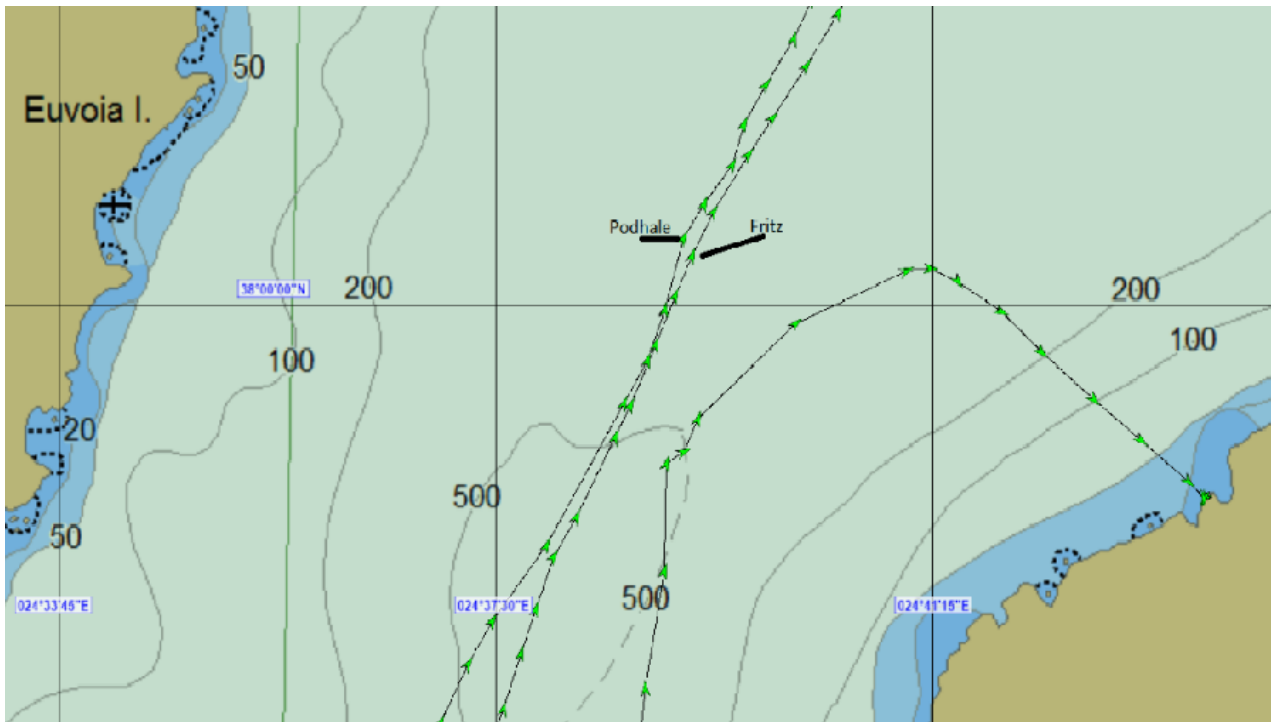
The courses of two other vessels that crossed Steno Kafireas strait approximately after two hours of Goodfaith's passage were also extracted from the Integrated Marine Data Environment in an attempt to evaluate their courses. The purpose was to examine their maneuverability and control of their steerage in comparison to Goodfaith. Based on the aforementioned data, the course of M/V Goodfaith was projected on an electronic chart, in comparison to the courses of the other vessels. An overview of the plotted positions is presented in the following figures:

**Figure 30:** An overview of the other two vessels' courses in relation to Goodfaith's course as extracted from AIS information system (source IMDatE).

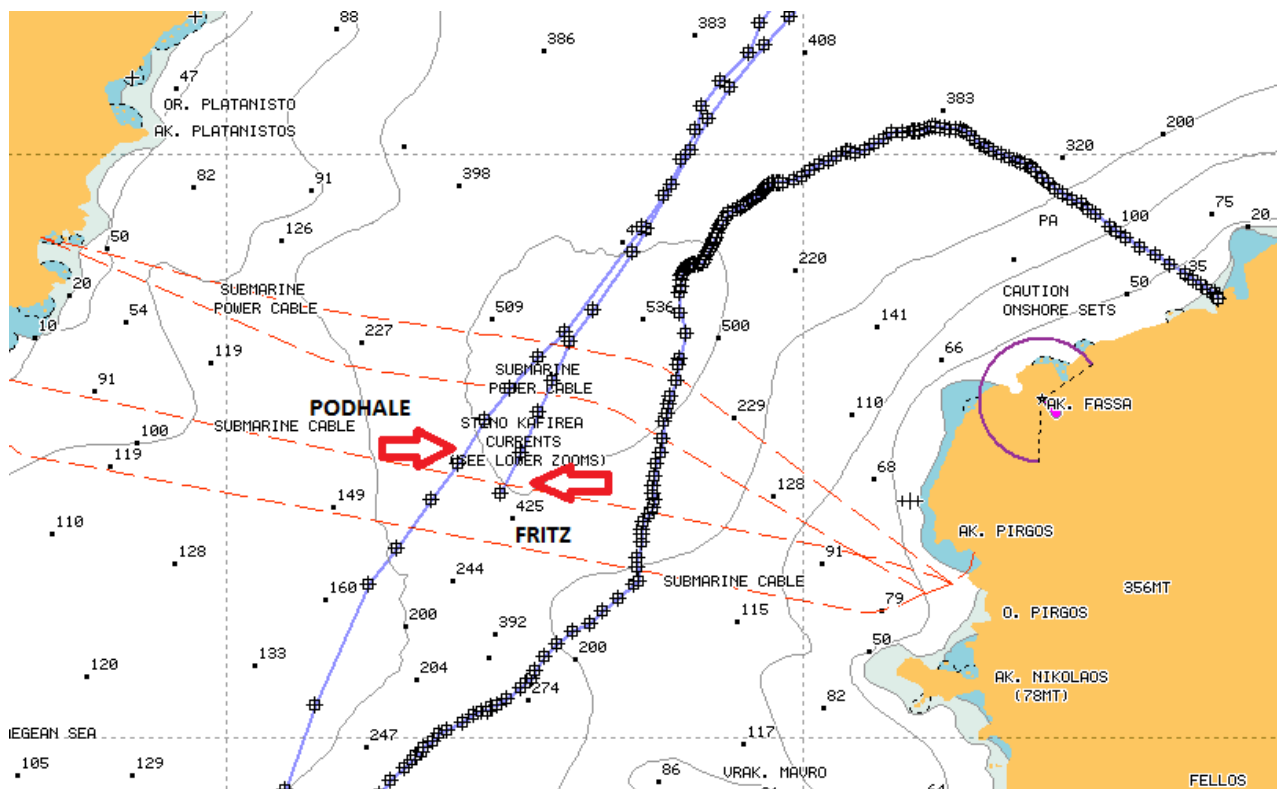
**Figure-31:** An overview of the other two vessels' courses in relation to Goodfaith course as plotted in the electronic chart (source HBMCI).

According to the information collected during the investigation process it derived that both vessels were Bulk Carriers of similar size with Goodfaith<sup>10</sup>, and were navigating in ballast condition. Nonetheless, it could not be verified if they were in heavy ballast condition. Comparing their courses with the course of Goodfaith in the chart, it was evident that both presented a better maneuverability and control of their steerage so ultimately they were able to maintain their original course despite the severe weather conditions. Moreover it is evident that both vessels were able to keep a steady course in relation to Goodfaith and this enabled them to successfully pass the strait.
