HELLENIC REPUBLIC
HELLENIC BUREAU FOR MARINE CASUALTIES INVESTIGATION
MARINE CASUALTY SAFETY INVESTIGATION REPORT
15/2013

Collision between
M/V BARU SATU & M/V KATHERINE
4.5 n.m. SE from Mantili Isl., Steno Kafirea, Greece

July 2018

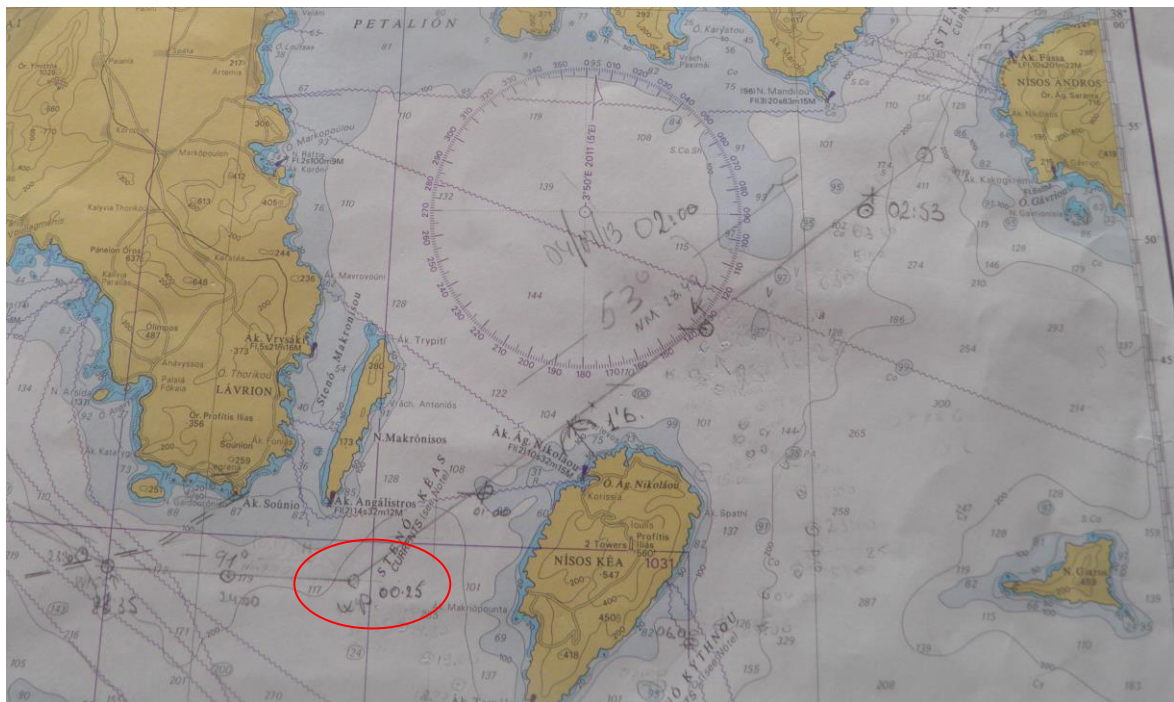
Picture 3.1/1: Photo of Baru Satu navigational chart

picture 3.1/1). The watch handover was performed without any remarks, speed was approximately 11.3 knots and one AB was posted as a look out. Both the radar and the ARPA were in operation as well as the rest of the navigational equipment. It was reported that the radars were operating on “HEAD UP” and “TRUE MOTION” mode at a range of 12 n.m.

After altering the course to 053° the Master went to his office for the ordinary correspondence with the vessel’s company however he visited the bridge at approximately 0120. At approximately 0200 he went to his cabin to rest and at the bridge remained the 2nd Officer, as the OOW, and the lookout AB. At that time Katherine was not spotted on the radars.

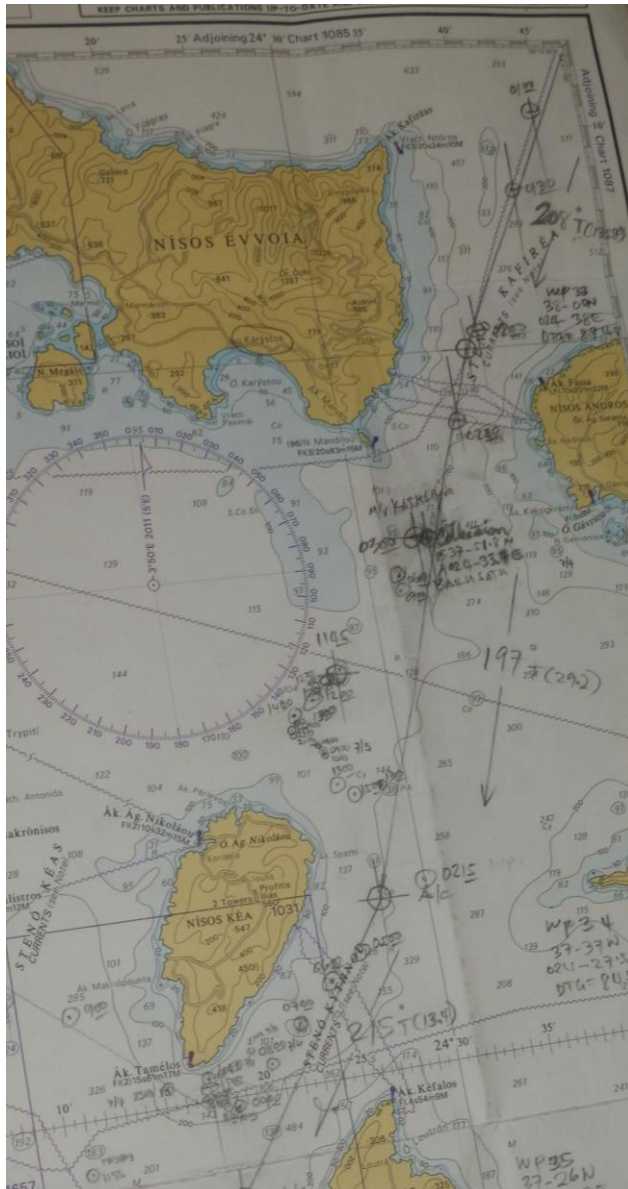
Picture 3.2/1: Photo of Katherine navigational chart

The previous day of the casualty Katherine exited Dardanelles Strait and headed SSW towards Steno Kaireas. Her planned passage provided a 208° course for crossing the Steno Kaireas followed by a 197° course towards the Steno Kythnou (see **picture 3.2/1**). At 0000 on the day of the casualty the 2nd Officer took over the navigational watch from the 3rd Officer without any remarks. All navigational equipment was in operation including the radar and the ARPA, speed was approximately 12 Knots and one AB was posted as a lookout. At approximately 0125 the Master came on the bridge and stayed for almost 15 minutes. He left the bridge at approximately 0140 and went to his cabin to rest. During that time Baru Satu was not spotted as it was not in

the 12 nm range that was set on the radars. Katherine was following a course of 197° and at approximately 0230 the course was altered to 200° as the position fixing was slightly port from the planned course.

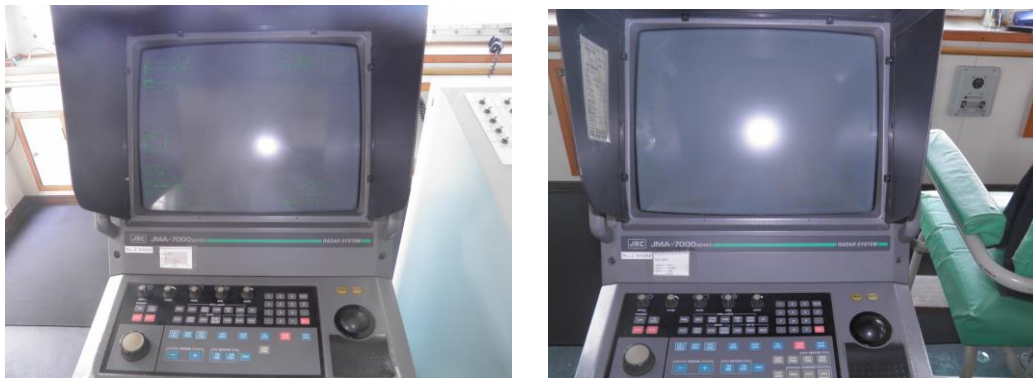
Pictures 4.1.1/1 & 2:
The two radars of Baru Satu.

It was reported that during the time of the casualty both radars were in operation.

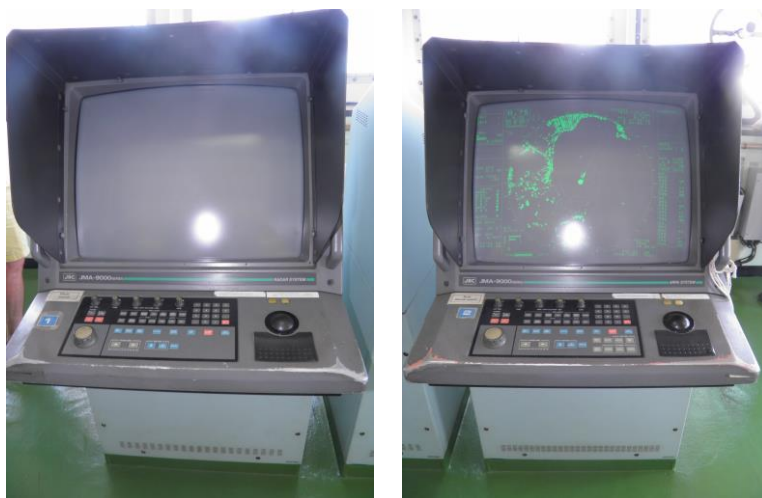
Pictures 4.1.2/1 & 2:
The two radars of Katherine.

It was reported that during the time of the casualty both radars were in operation and set at a range of 12nm.
