SAFETY RECOMMENDATION No: 20/2015

03/2015: Death by asphyxiation of the Bosun of Bulk Carrier KOSMAS V, Panama Flag, IMO 9445681, after entering a cargo hold

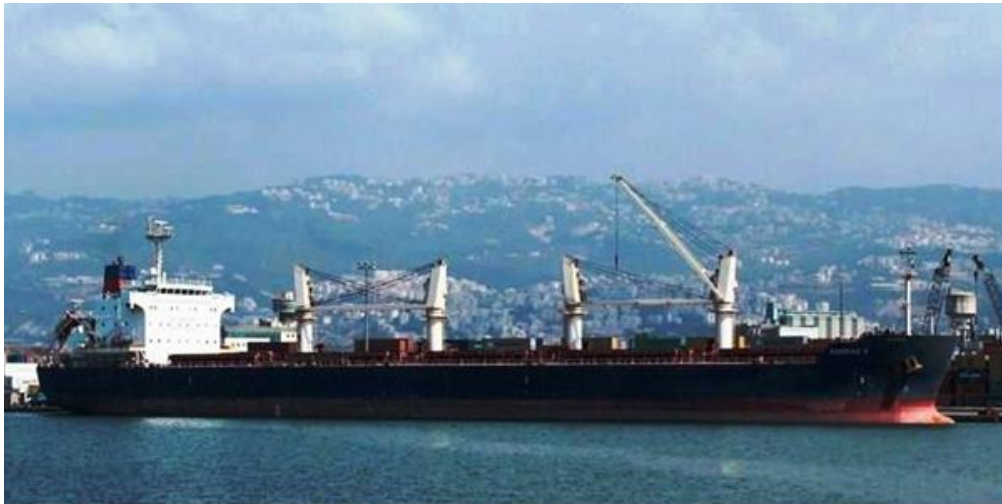
Bulk carrier KOSMAS V.

Kosmas V, under Panama Flag, was a five cargo holds 57,000 tons Handymax Bulk carrier, geared with four cranes that was built in China in 2011. By the time of the marine casualty she was engaged in international trade.
