SAFETY RECOMMENDATION No: 23/2015

03/2015: Death by asphyxiation of the Bosun of Bulk Carrier KOSMAS V, Panama Flag, IMO 9445681, after entering a cargo hold

Death by asphyxiation of the Bosun of Bulk Carrier KOSMAS V, Panama Flag, IMO 9445681, after entering a cargo hold

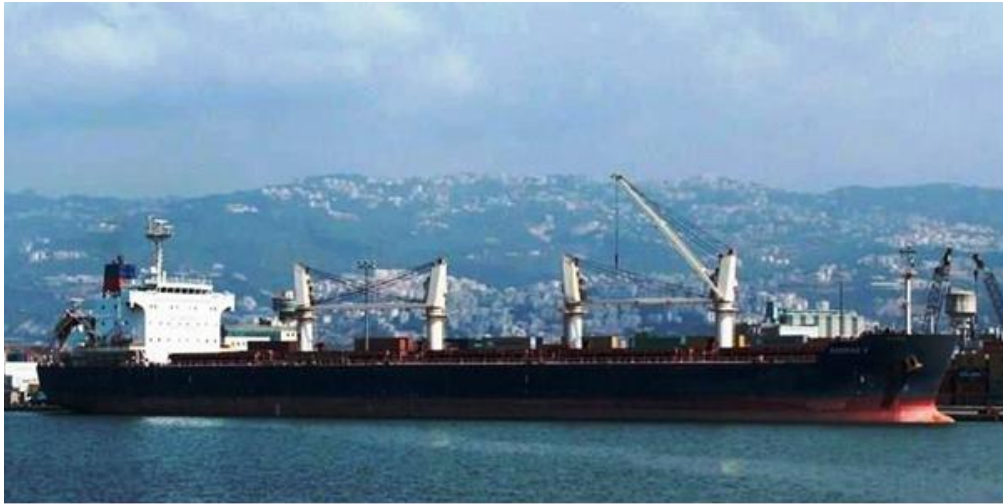
Kosmas V, under Panama Flag, was a five cargo holds 57,000 tons Handymax Bulk carrier, geared with four cranes that was built in China in 2011. By the time of the marine casualty she was engaged in international trade.

Bulk carrier KOSMAS V.
