INTERIM REPORT

MARINE ACCIDENT SAFETY INVESTIGATION

Grounding of B/C "GOODFAITH" CYPRUS FLAG IMO 9076404

Very Serious marine casualty

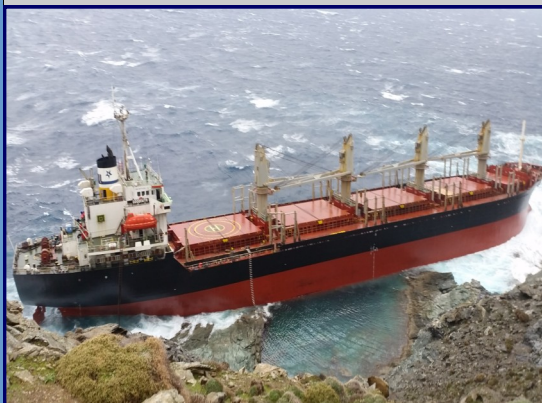
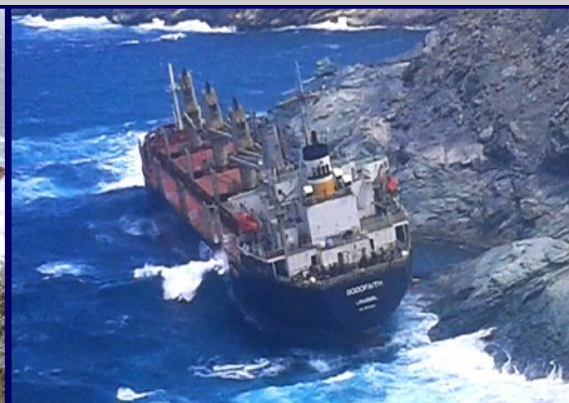
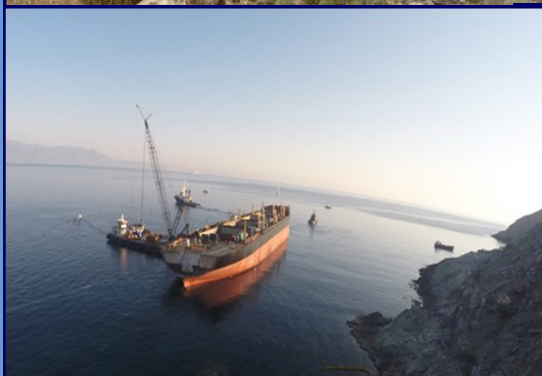
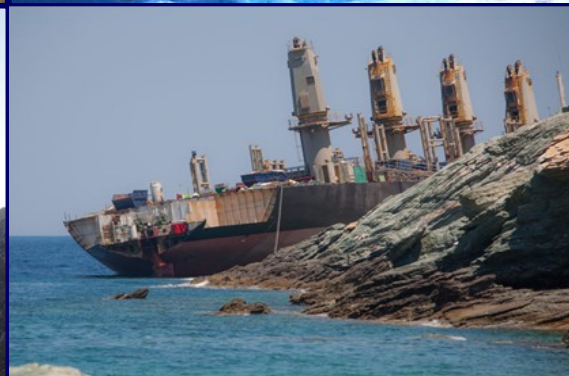
Goodfaith had sustained severe damages, heavy indentations, cracks and fractures lengthwise on her bottom; cargo holds no 1,3,4,5, forepeak tank and engine room compartments were holed and flooded; a limited pollution also occurred.
