SAFETY RECOMMENDATION No: 15/2013

No of Safety Investigation Report:	03/2013: Foundering of barge "AGIOS DIONYSIOS" <i>(See the full Report here.)</i>
---	--

Foundering of barge

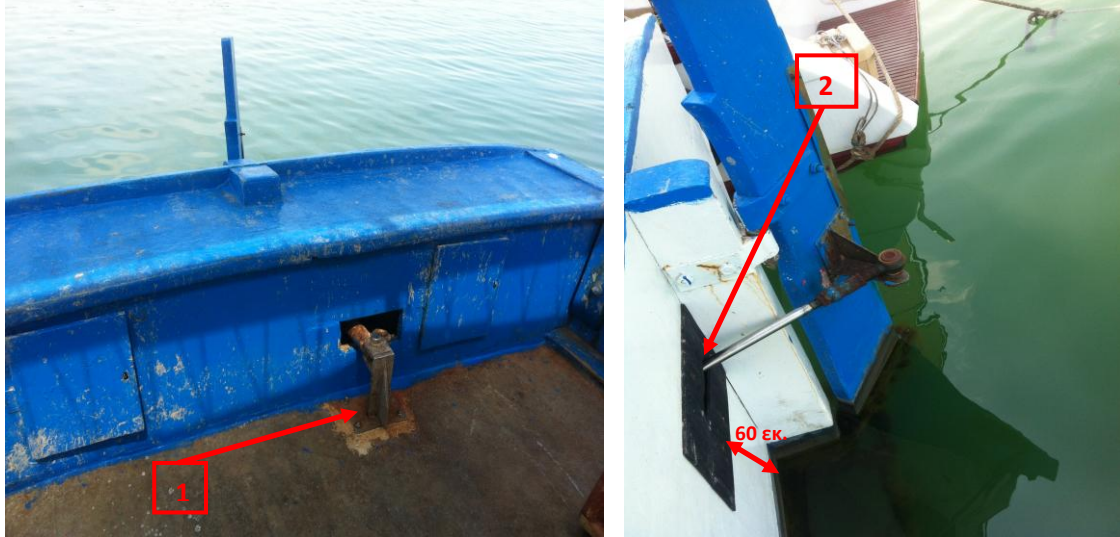
According to the collected data of the conducted investigation, it is presumed that the vessel's sinking was due to water ingress in the engine area, which should be watertight. This ingress derived from holes in the aft deck and stern transom, from which the steering mechanism passed. The area of openings was covered by a wooden structure, which did not allow the detection of water ingress by the Skipper or the other persons on board.

Picture 2: The bearing point of steering gear (1) and the point from which the rudder mechanism penetrated the hull of the ship (2).
