SAFETY RECOMMENDATION No: 18/2014

02/2014: Grounding of B/C "INCE INEBOLU"
(See the full Report [here.](#))

Grounding of B/C "INCE INEBOLU"

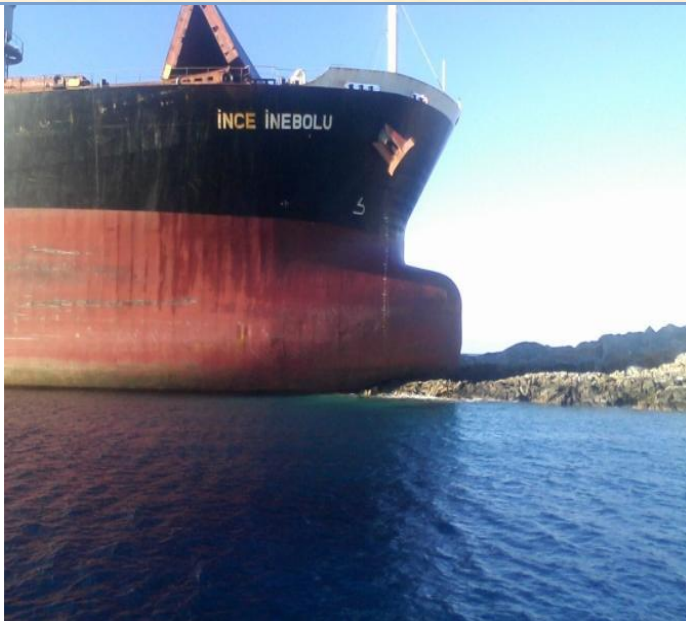
Grounding point of Ince Inebolu at Astypalaia Island.

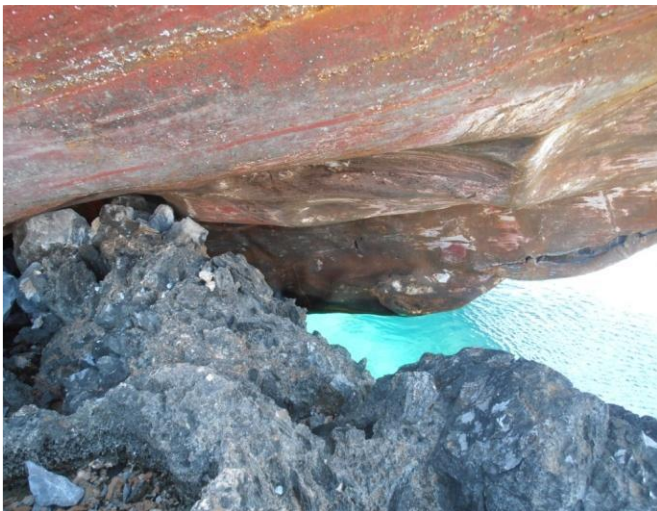
Due to the heavy impact on the rocky coastline, several compartments of her bow section were damaged to an extent of about 21 m of length longitudinally. More specific the damages reported to be cracks and hull plating deformation at forepeak tank, collision bulkhead, No. 1 cargo Hold, No 1 port and starboard ballast tanks. No injuries and no pollution was reported.

Deformed starboard bottom fore section.

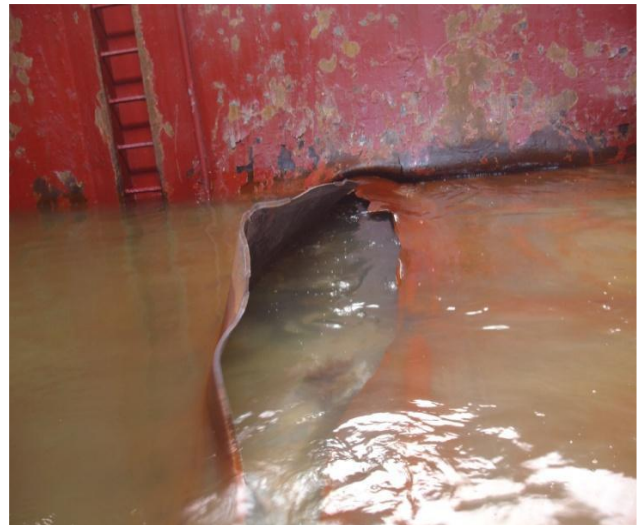
The crack at inner bottom plate of No 1 cargo hold.
